***Velibor SPALEVIĆ¹, Milić ČUROVIĆ¹, Dragan BOROTA²
and Budimir FUŠTIĆ¹***

SOIL EROSION IN THE RIVER BASIN ŽELJEZNICA, AREA OF BAR, MONTENEGRO

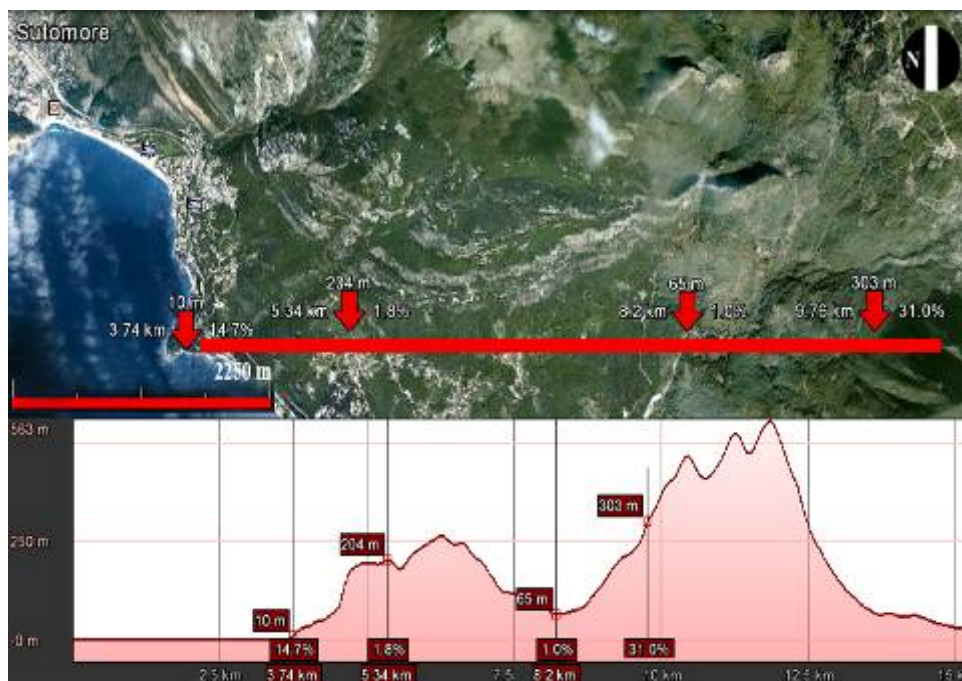
Figure 4: Cross-section Ratac – Zupci

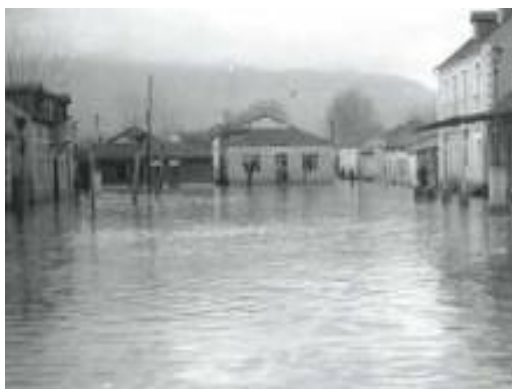
Figure 6: Floods caused by river Rena on January 25, 1955

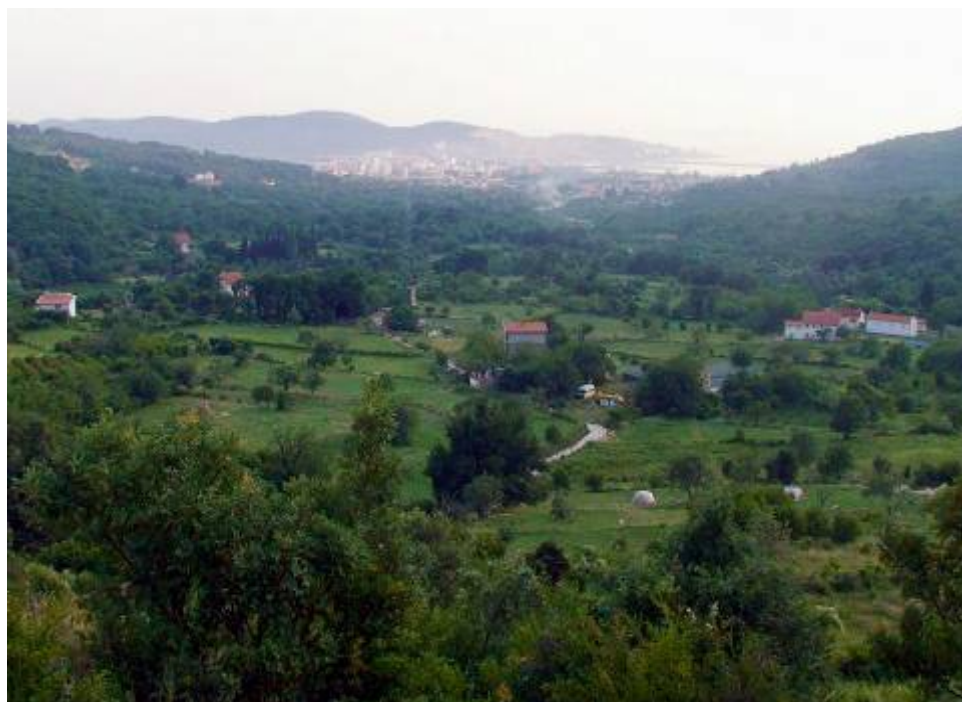
Figure 8. The village of Zupci, showing the upper part of Željeznica river basin

Large blocks of rocks can be found in the river bed, which shows the great energy of this river. Downstream of the confluence with the Velja river, the Željeznica has carved out a bed in the porous and sandy material. In some places, the bed is as wide as 150 metres as a result of meandering and relocation of the bed. During times of high water levels, this river moves significant quantities of erosion material into the surrounding land in the valley.
